Infrared Inspection Report

1234 Sample St, Anywhere

Report Number:

070312-2

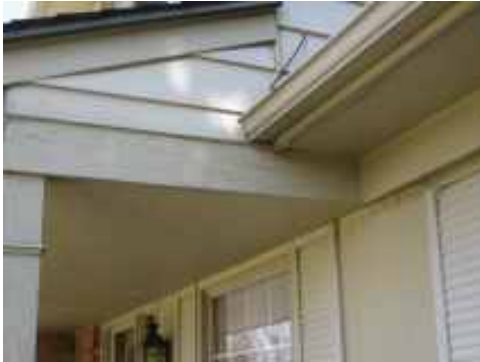
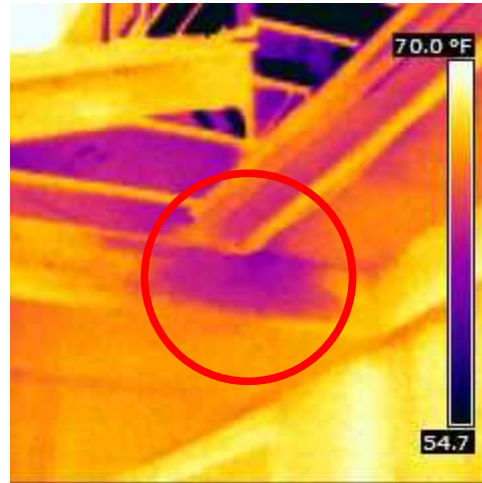
High moisture content is visible at the fascia board below the gutter. A moisture meter had a reading of 45%. Some of the wood is rotted and should be replaced. The gutter and flashings in this area should be investigated and repaired as necessary.

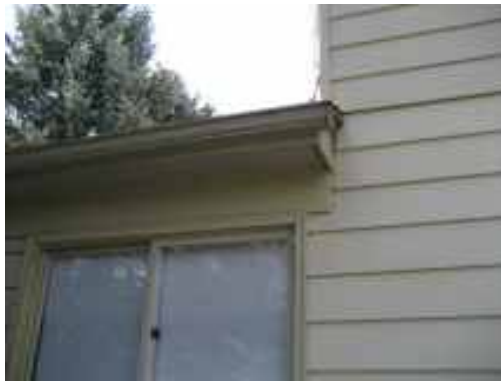
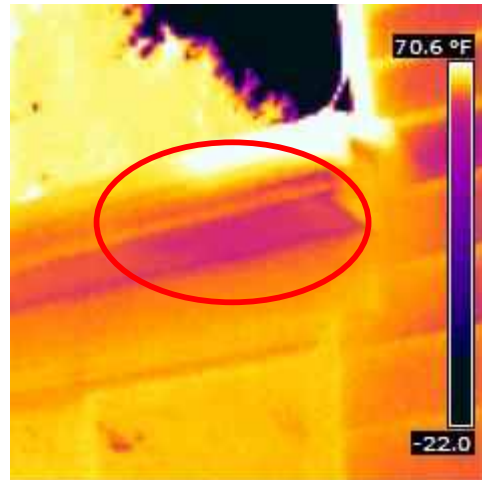
High moisture content is visible at soffit above rear dining room window. A moisture meter had a reading of 28%. The gutter and flashings in this area should be investigated and repaired as necessary.

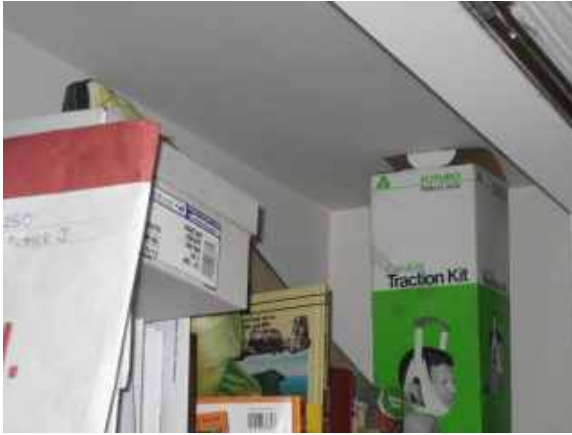
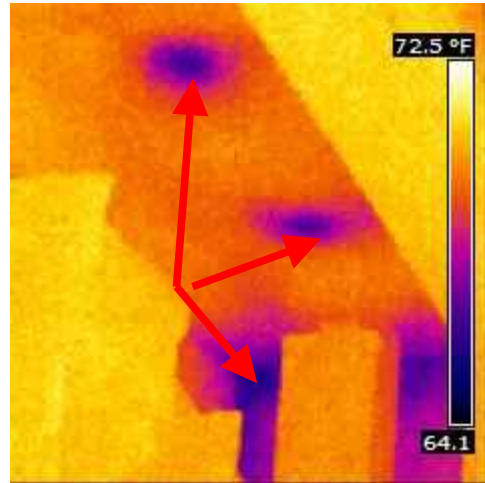
Missing insulation and air infiltration above southeast guest bedroom closet ceiling.

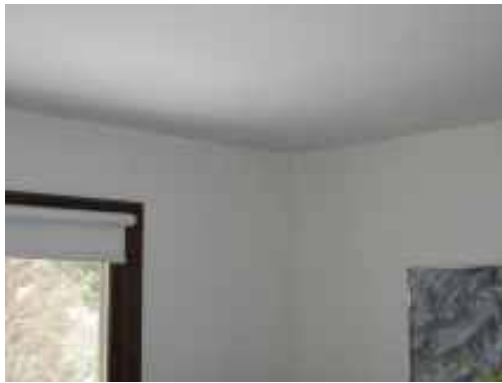
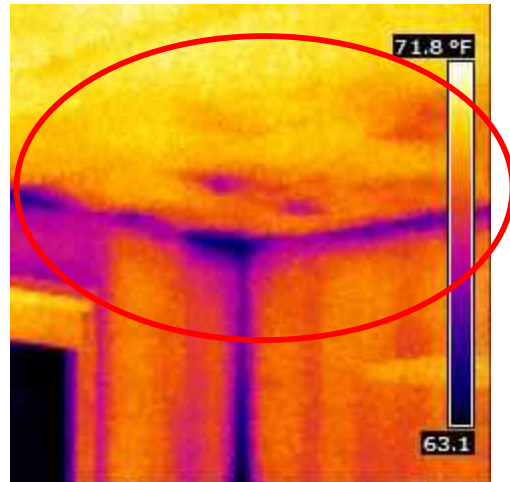
Poor/missing insulation and air infiltration at southeast corner of southeast guest bedroom.

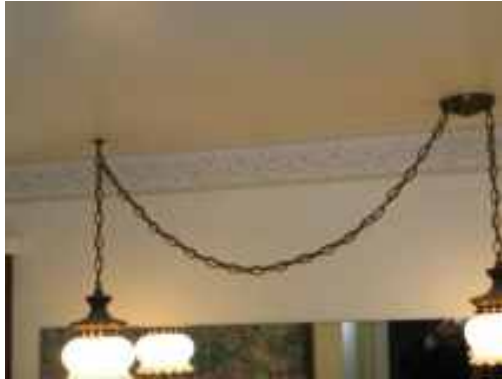
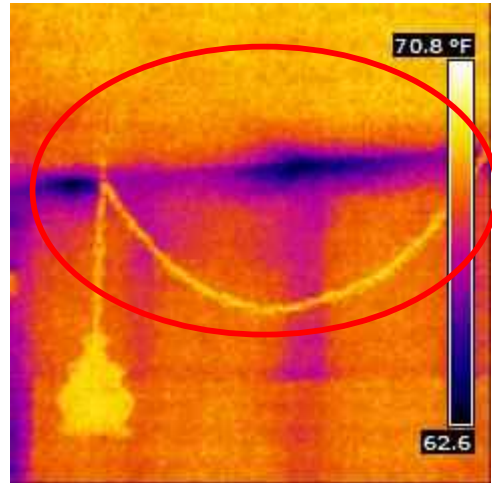
Air infiltration at ceiling and outside wall in hall bath.

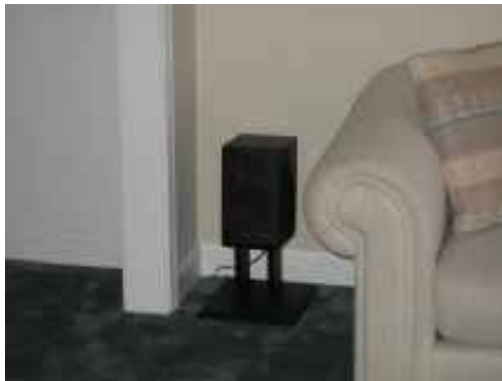
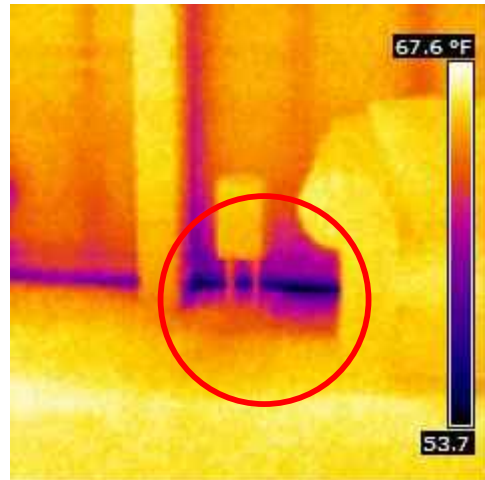
Air infiltration at base of south living room wall.

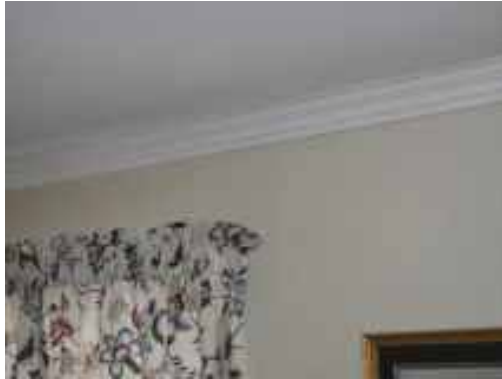
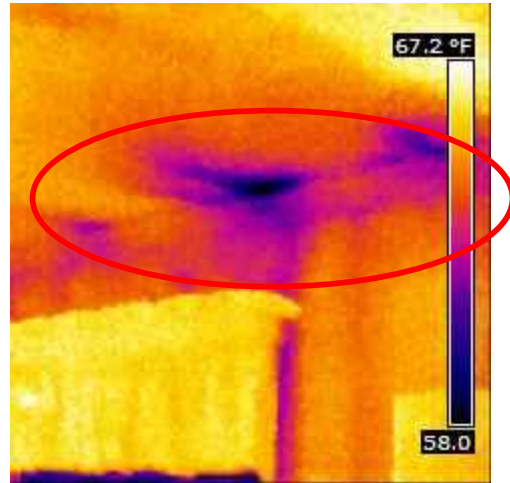
Air infiltration at west living room wall and ceiling.

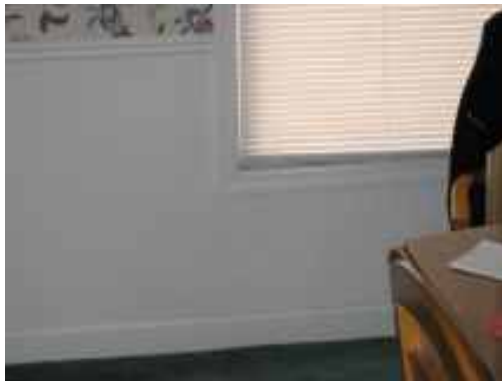
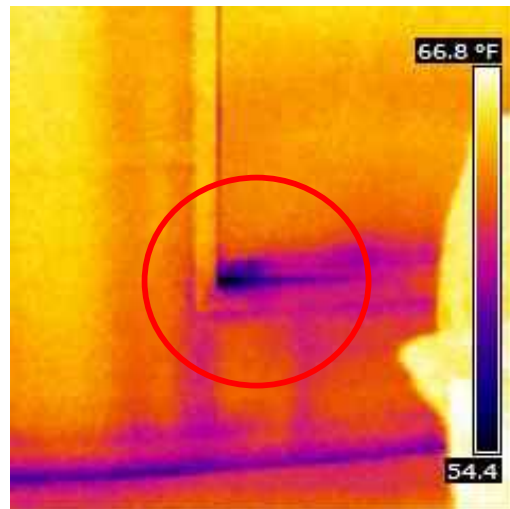
Air infiltration at base of dining room window.

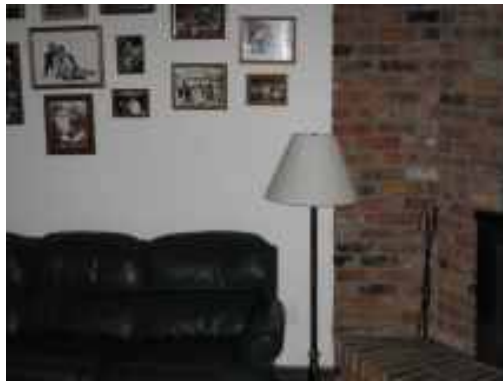
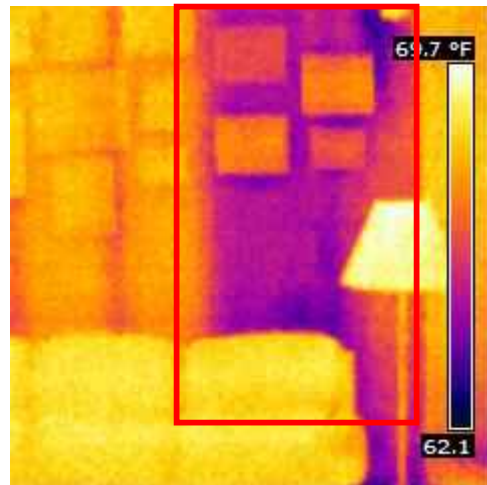
Poorly installed and/or missing insulation.
