# Building Inspection Report

## 700 Sample St, Anywhere, USA

11/21/2014

141121-1

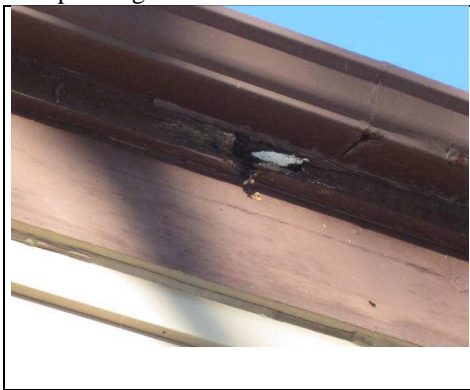
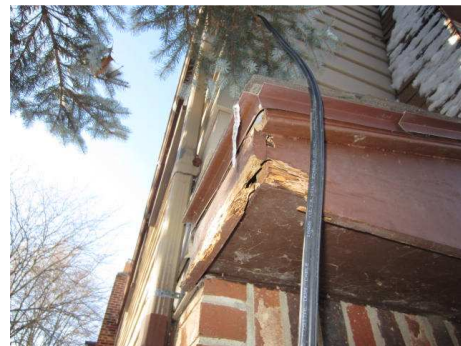
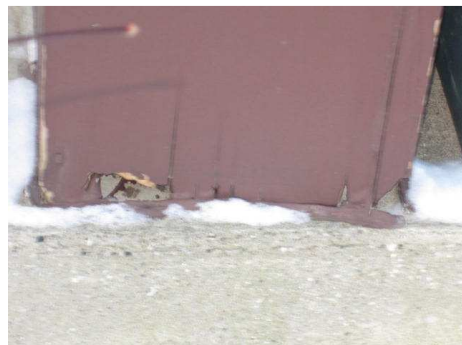
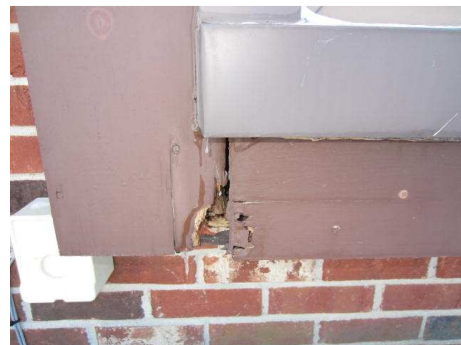
- **Improve:** Localized rot was observed in the siding/trim in several locations. Repairs should be performed in conjunction with painting.

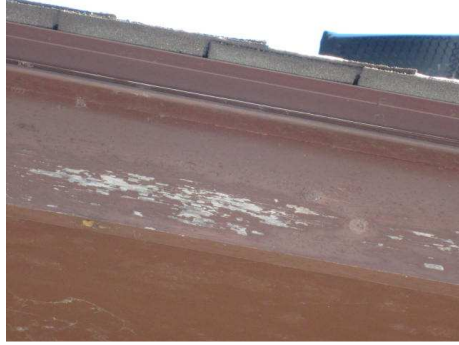
- **Improve:** The wood siding/trim needs caulking and painting.

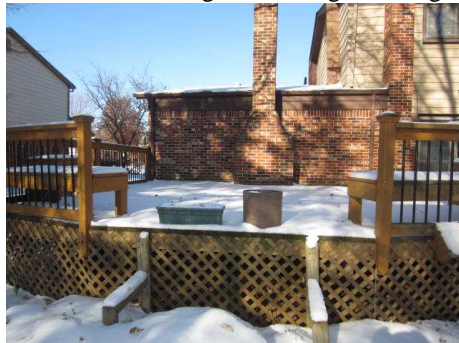
- **Safety Issue:** As there is a danger of falling, a railing should be provided for all areas of the deck.

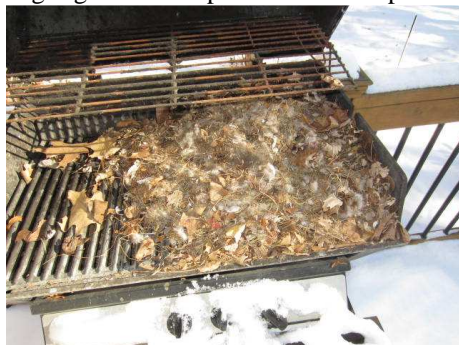
- **Monitor:** Some settlement of the deck is visible. As a result the deck is not level. This is a common condition. Repairs can usually be performed by a skilled carpenter if desired.
- **Monitor:** The gas grill was inoperable at the inspection and filled with an animal nest.

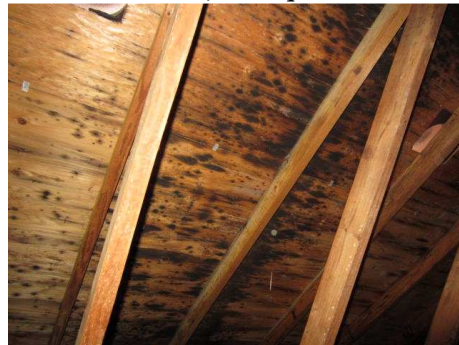
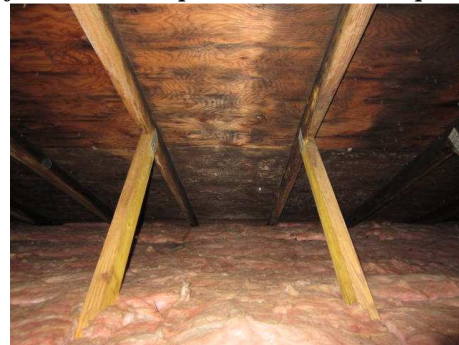
- **Major Concern:** Evidence of condensation and mold/mildew was observed in the upper attic. This condition is the result of insufficient ventilation and/or too much humidity. Ventilation and humidity levels should be improved as necessary. *Some molds, mildew and other conditions of like nature are believed to cause illness or disease in some people. Conditions that allow for the growth of mold/mildew should not be allowed to persist. Further investigation is needed to determine the causes, consequences and means of correction. Improvements will be expensive.*

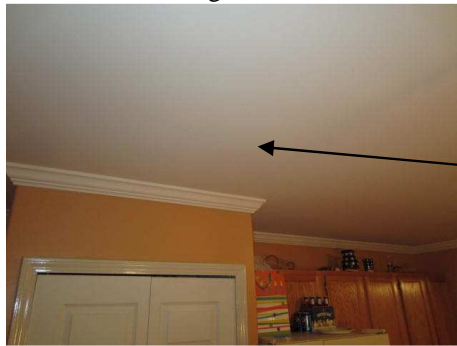
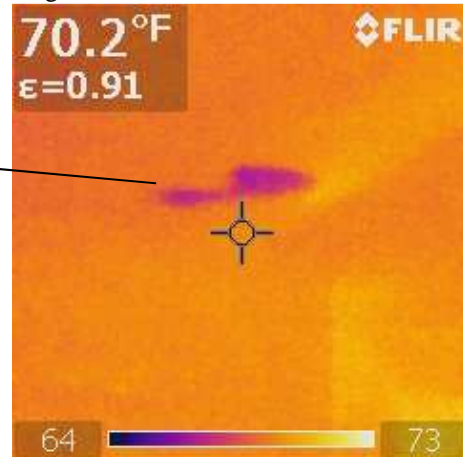
- **Improve:** High moisture was detected at the kitchen ceiling under the master bath shower from an ongoing plumbing leak. Further investigation is needed to determine what repairs are necessary. The darker area in the thermal image on the right below shows the area of high moisture at the kitchen ceiling from the shower leak above.

- **Improve:** The shower valve is leaking at packing/seal.
- **Improve:** The showerhead/valve was inoperable at the inspection.

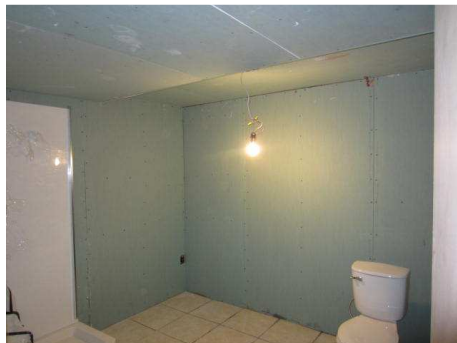
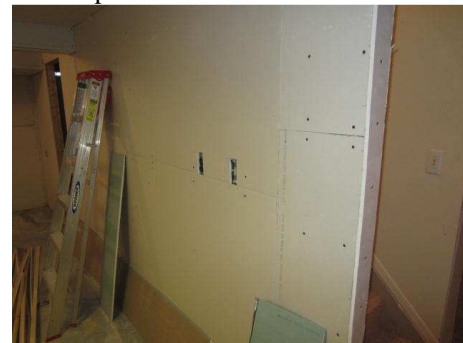
- **Improve:** The installation of the basement interior finishes is incomplete.

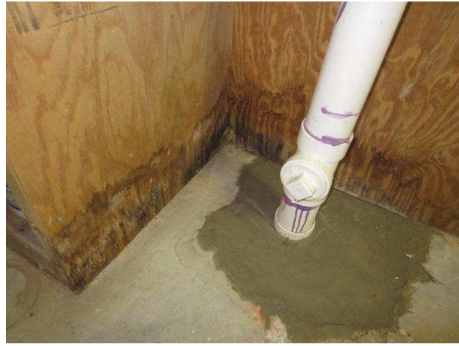
- **Monitor:** Water staining/damage was noted at base of basement wall from previous possible previous plumbing leak. Construction was dry at the inspection.

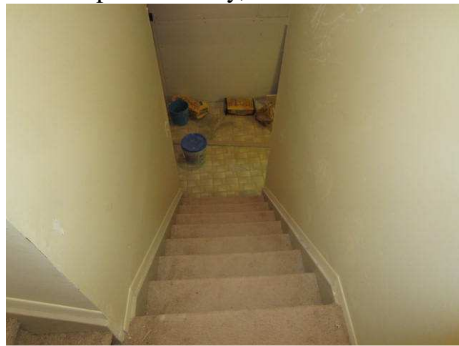
- **Safety Issue:** For improved safety, it is recommended that a handrail be provided for the basement stairway.

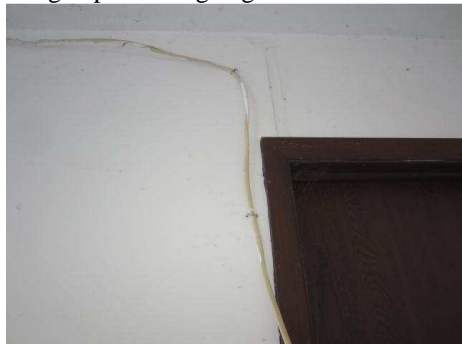
- **Improve:** Wiring exposed on garage walls should be relocated or protected by conduit.

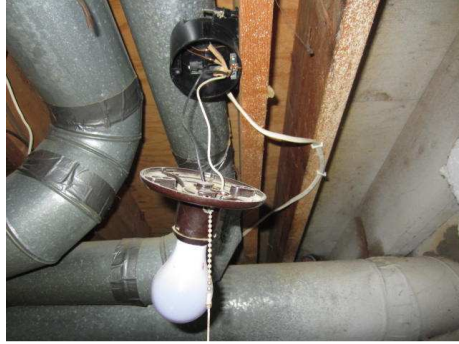
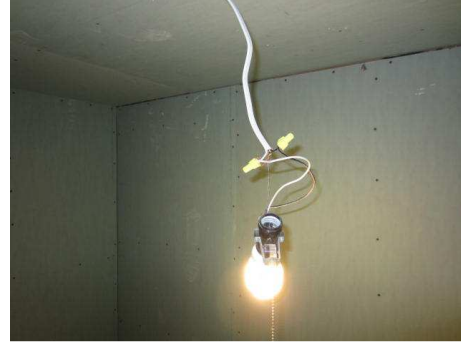
- **Safety Issue:** The loose hanging light fixtures in basement should be repaired.

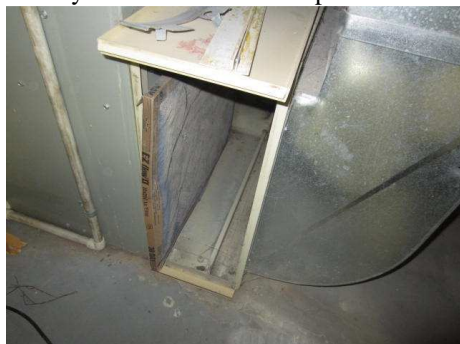
- **Improve:** The dirty air filter should be replaced with a full size filter. Periodic replacement is needed.

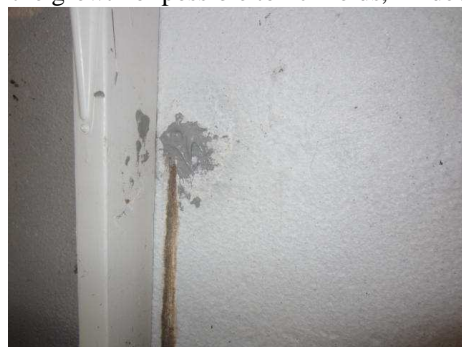
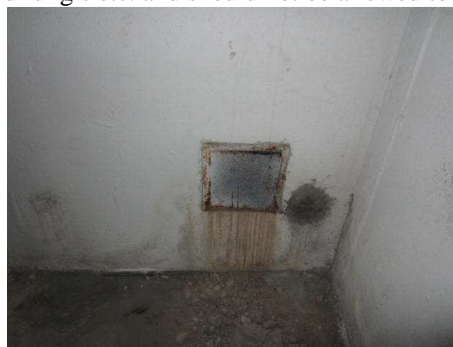
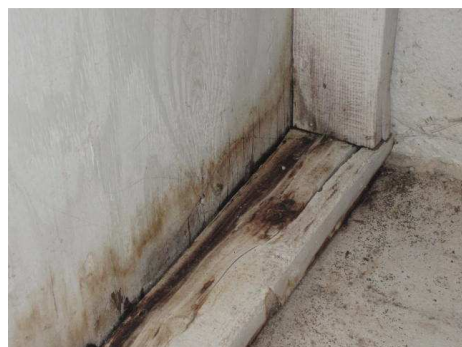
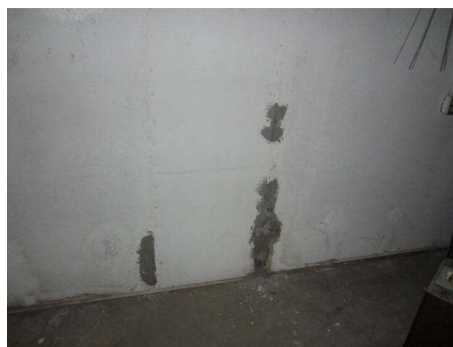
- **Monitor:** There is evidence (staining/moisture damage) of previous moisture penetration at wall penetration, cracks and rod holes noted. It is very common for wall penetrations, minor shrinkage and/or settling cracks and rod holes to leak. If leakage is experienced, the ground around the house should be sloped to encourage water to flow away from the foundations. Gutters and downspouts should act to collect roof water and drain the water at least five (5) feet from the foundation. If leakage persists, various methods of crack repair are available, including interior patching with an epoxy resin or hydraulic cement, and exterior repairs after excavation. High moisture environments in finished basements are conducive to the growth of possible toxic molds, mildews and fungus etc. and should not be allowed to persist.
